How to verify and upgrade software via SoftAP for Link HUB/UI at office

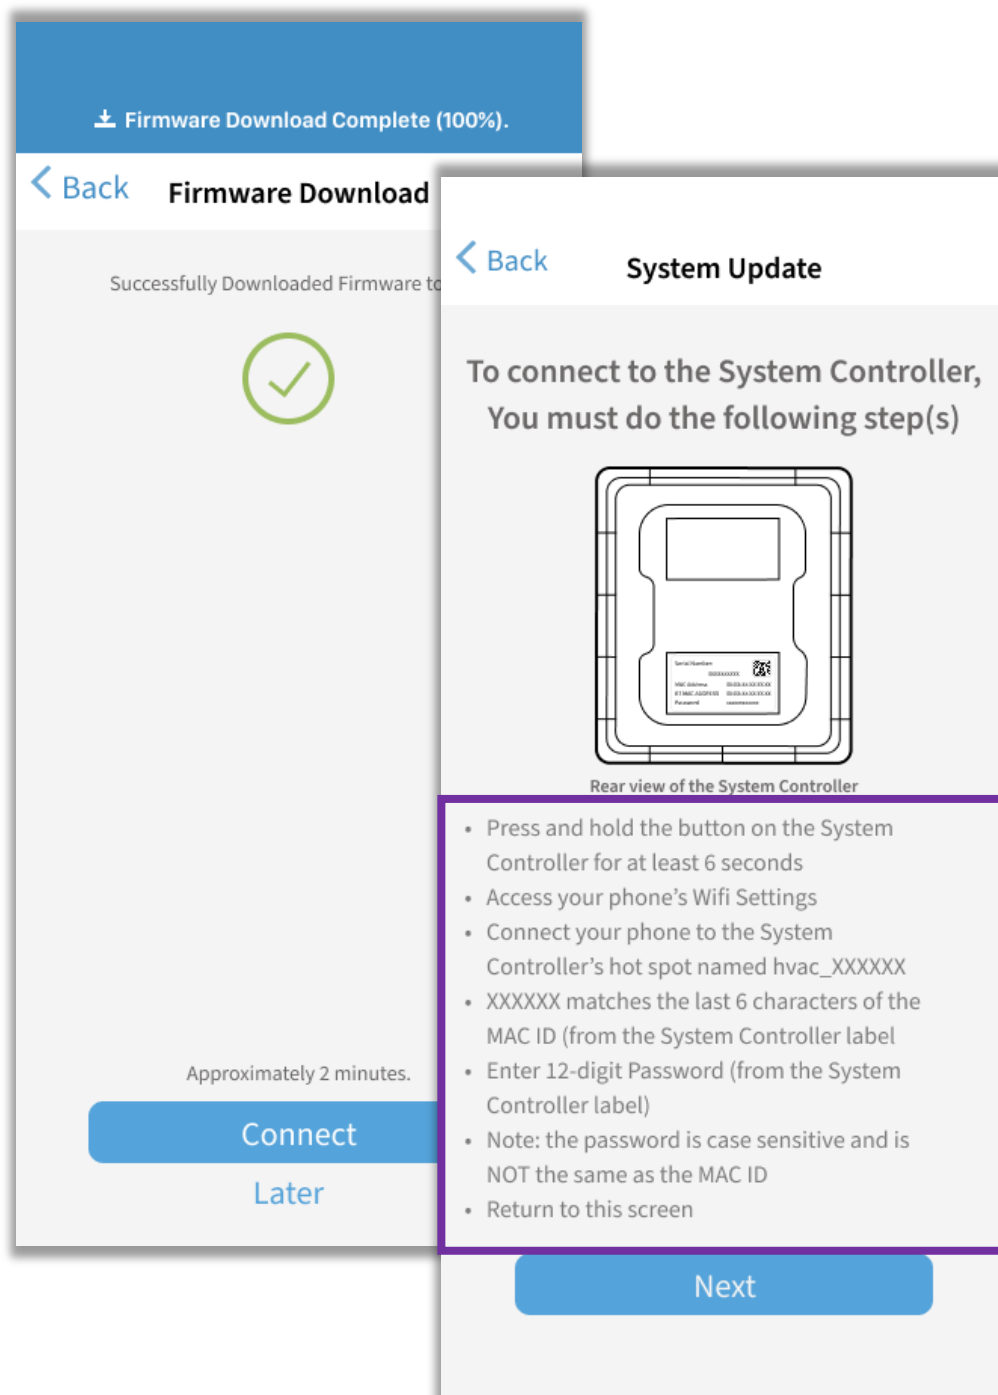
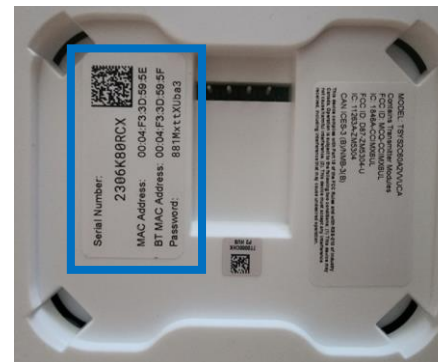
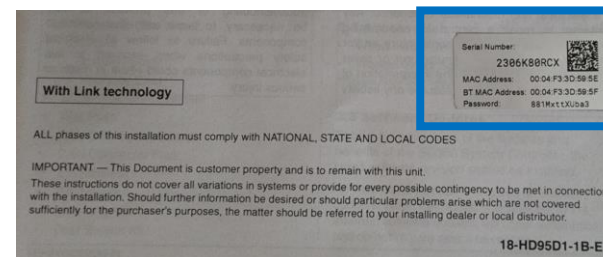
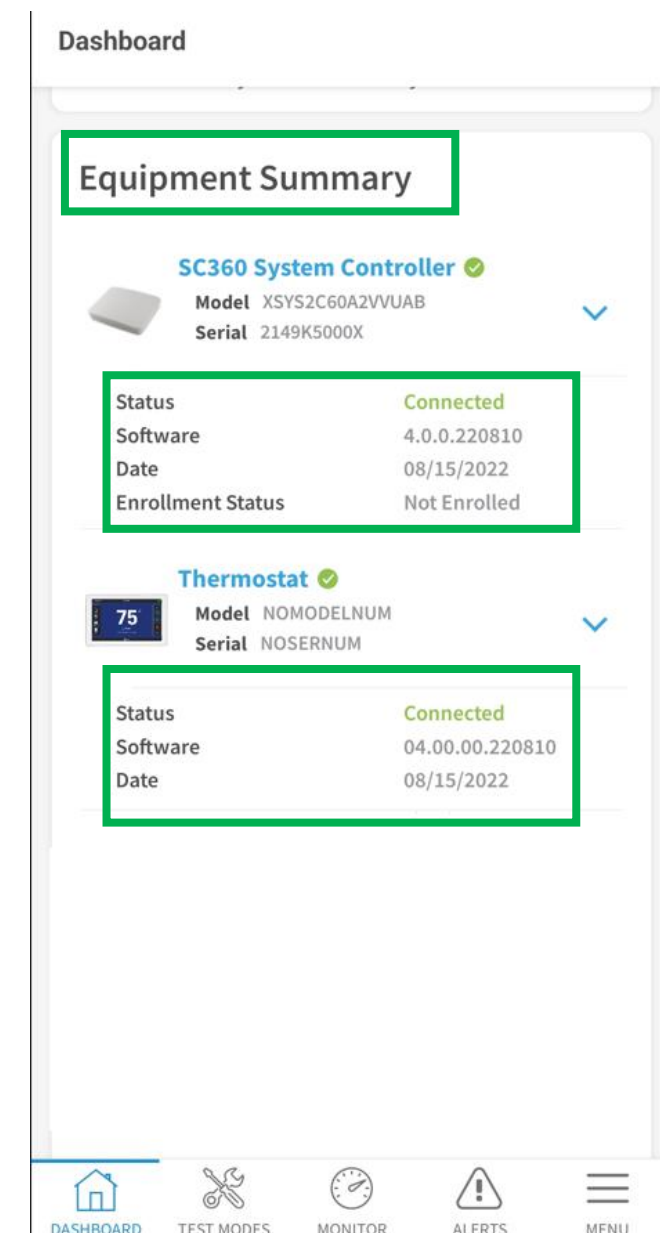
Once Firm is downloaded, Connect to the System Controller(HUB) following the instructions provided. You will need the password that is shown on the Hub label located on the device and manual. It is case sensitive.

It will take a few mins to upload software from your smart device to the HUB. Once completed your smart device does not need to remain connected. It will take approximately 2 hrs for the update to be unpacked and installed in the HUB and UI. Ensure that both components have power during that time. Connect to hub via diagnostic app or view on the UI in Summary table confirm the devices software.
